Manhole Inspection Summary

Manhole # S15K__002MH

Insp Date: **4/2/08 10:20 AM**

Location Address: **300 stinson st**

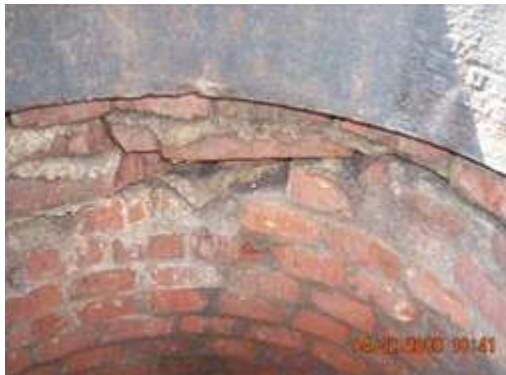
Defect 2

Infiltration: ☐ None ☐ Joint ☐ Cracks ☐ Mortar ☐ Roots ☒ **Wall**

infiltration @ corbel wall

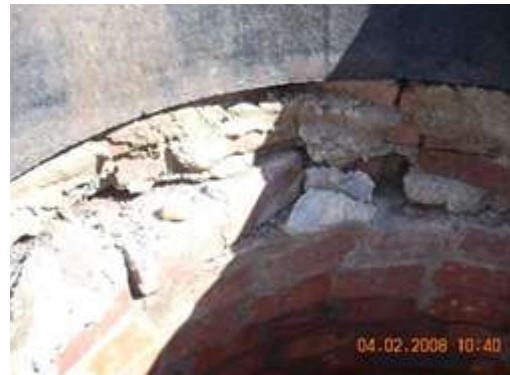
Defect 1

Condition: ☐ Sound ☐ Cracked ☐ Root Intrusion ☒ **Loose Brick** ☒ **Deteriorated**

loose bricks and deteriorated chimney

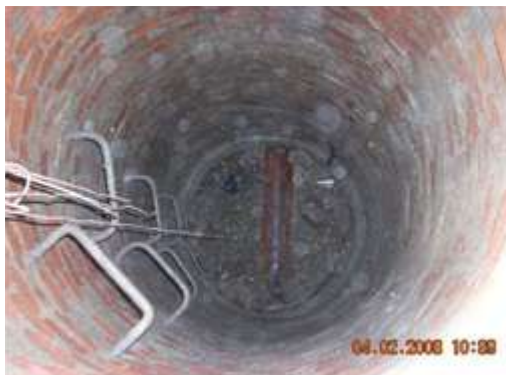
Defect 3

Condition: ☐ Sound ☐ Cracked ☐ Root Intrusion ☐ Deteriorated ☐ Leaks ☒ **Debris**

bench cond debris

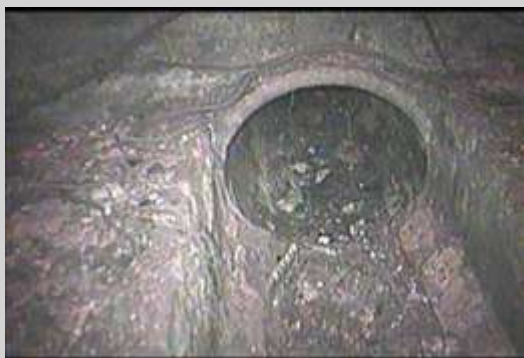
6 O'Clock Inflow

Pipe Height: **8.4** (in.) Rod and Bar (Angled)
Pipe Material: **Clay** ☐ Pipe Lined
Invert Depth: **14.54** (ft.) Flow Characteristics: **None**
Deposits: ☐ None ☒ **Mud** ☐ Sludge ☐ Debris ☐ Grease
Silt Depth: **1** (in.) Deposits Extent: **Light**
Infiltration: **None** Pipe Seal Cond: **Sound**
